OPTIMIZING THE COMBINATION OF STRENGTH AND
STRESS-CORROSION RESISTANCE OF 7075
ALUMINUM BY THERMAL-MECHANICAL TREATMENTS

Final Report
(15 September 1968 through 15 March 1969)

By
A. J. Jacobs

By
Rocketdyne
A Division of North American Rockwell Corporation
Canoga Park, California

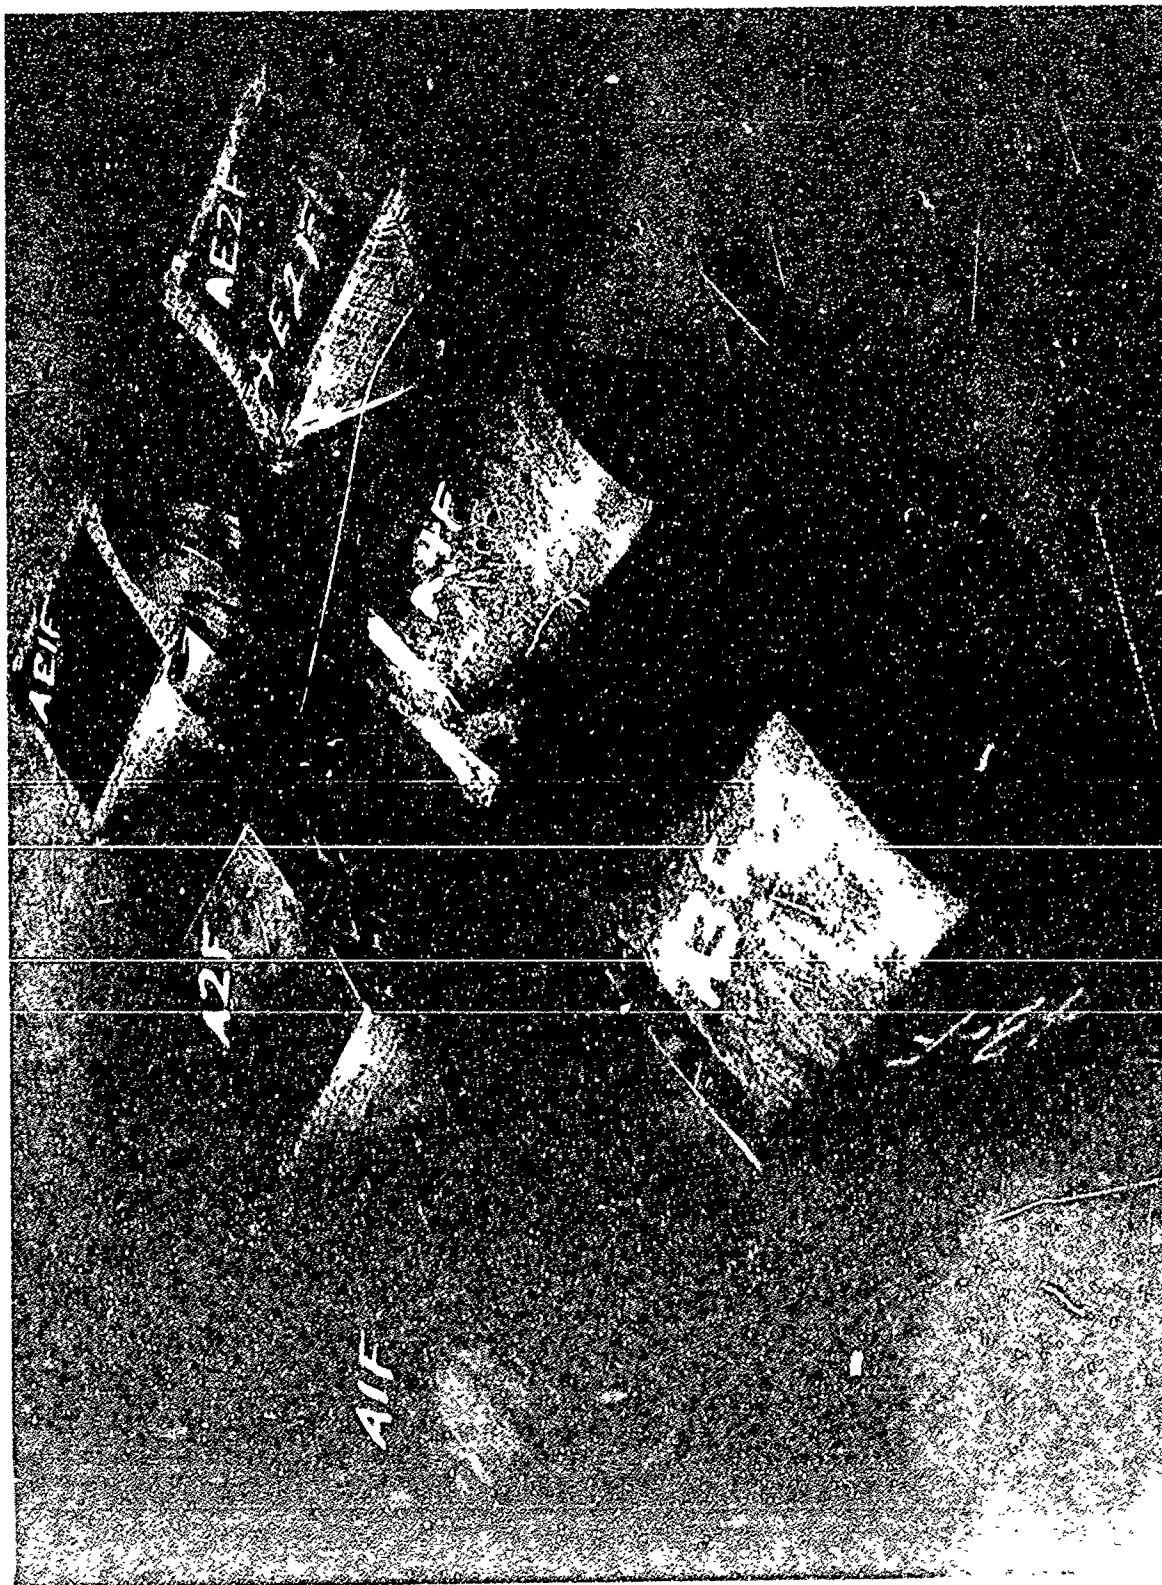
5AC23-11/12/68-C1C

Figure 2. Forged Blocks from Overaged Billet AF.

was necessary to prevent cracking in all but the most highly overaged condition (CF). The individual blocks from each billet were compressed once in the short transverse and once in either the longitudinal or long transverse directions. The reductions in area that were obtained are listed in Table III. Photographs of the forged blocks are shown in Figure 2; the blocks are oriented as they were in the original forgings.

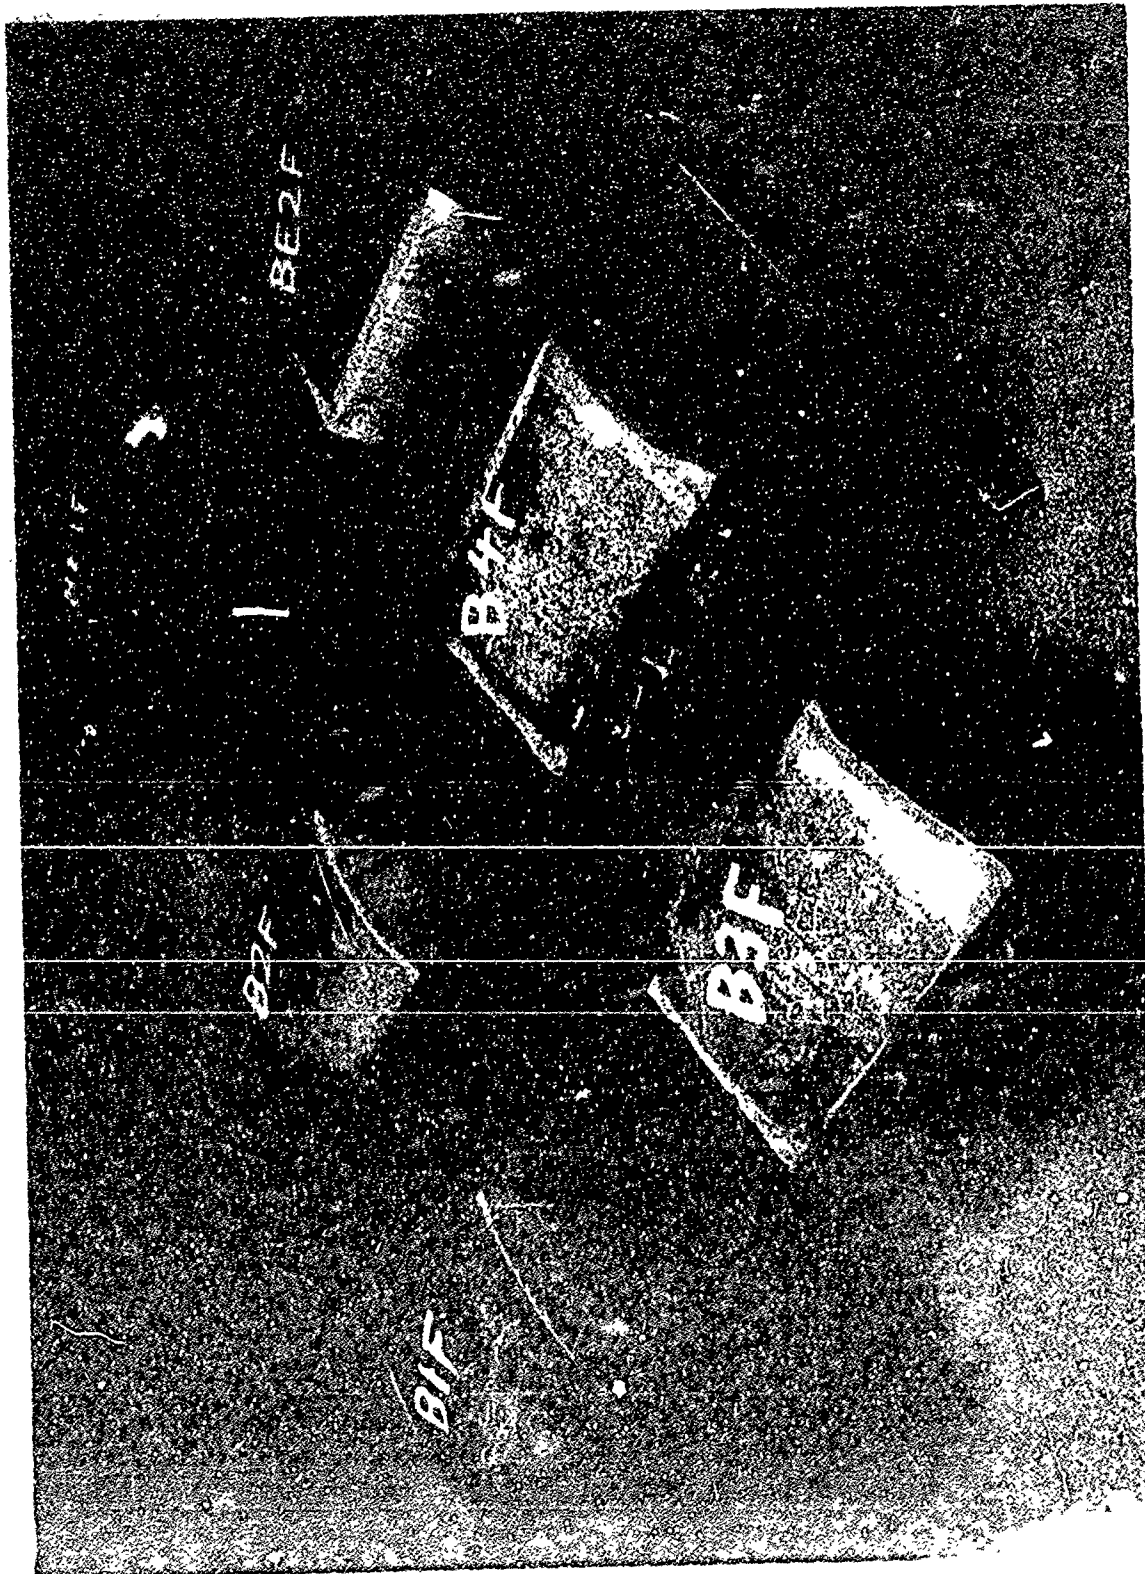
5AG23-11/12/68-1B

Figure 2. Forged Blocks from Overaged Billet BF.

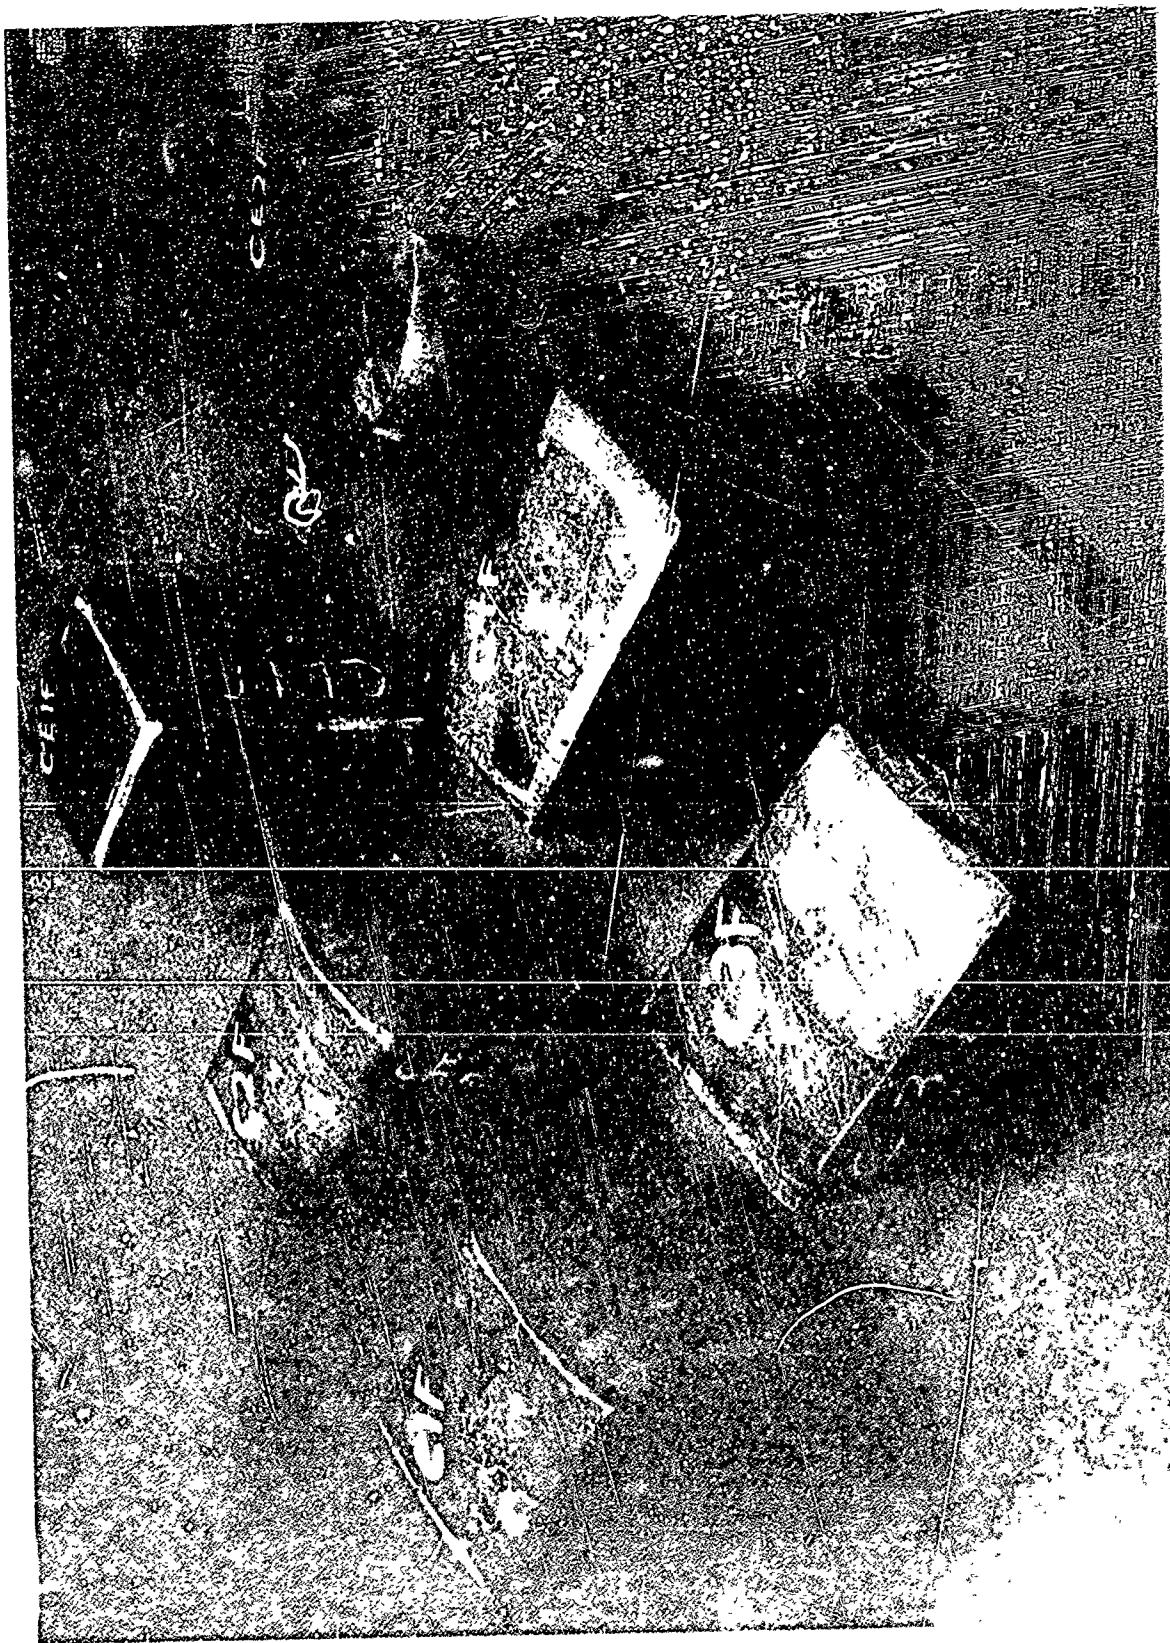
5A023-11/12/68-01A

Figure 2. Forged Blocks from Overaged Bullet CF.

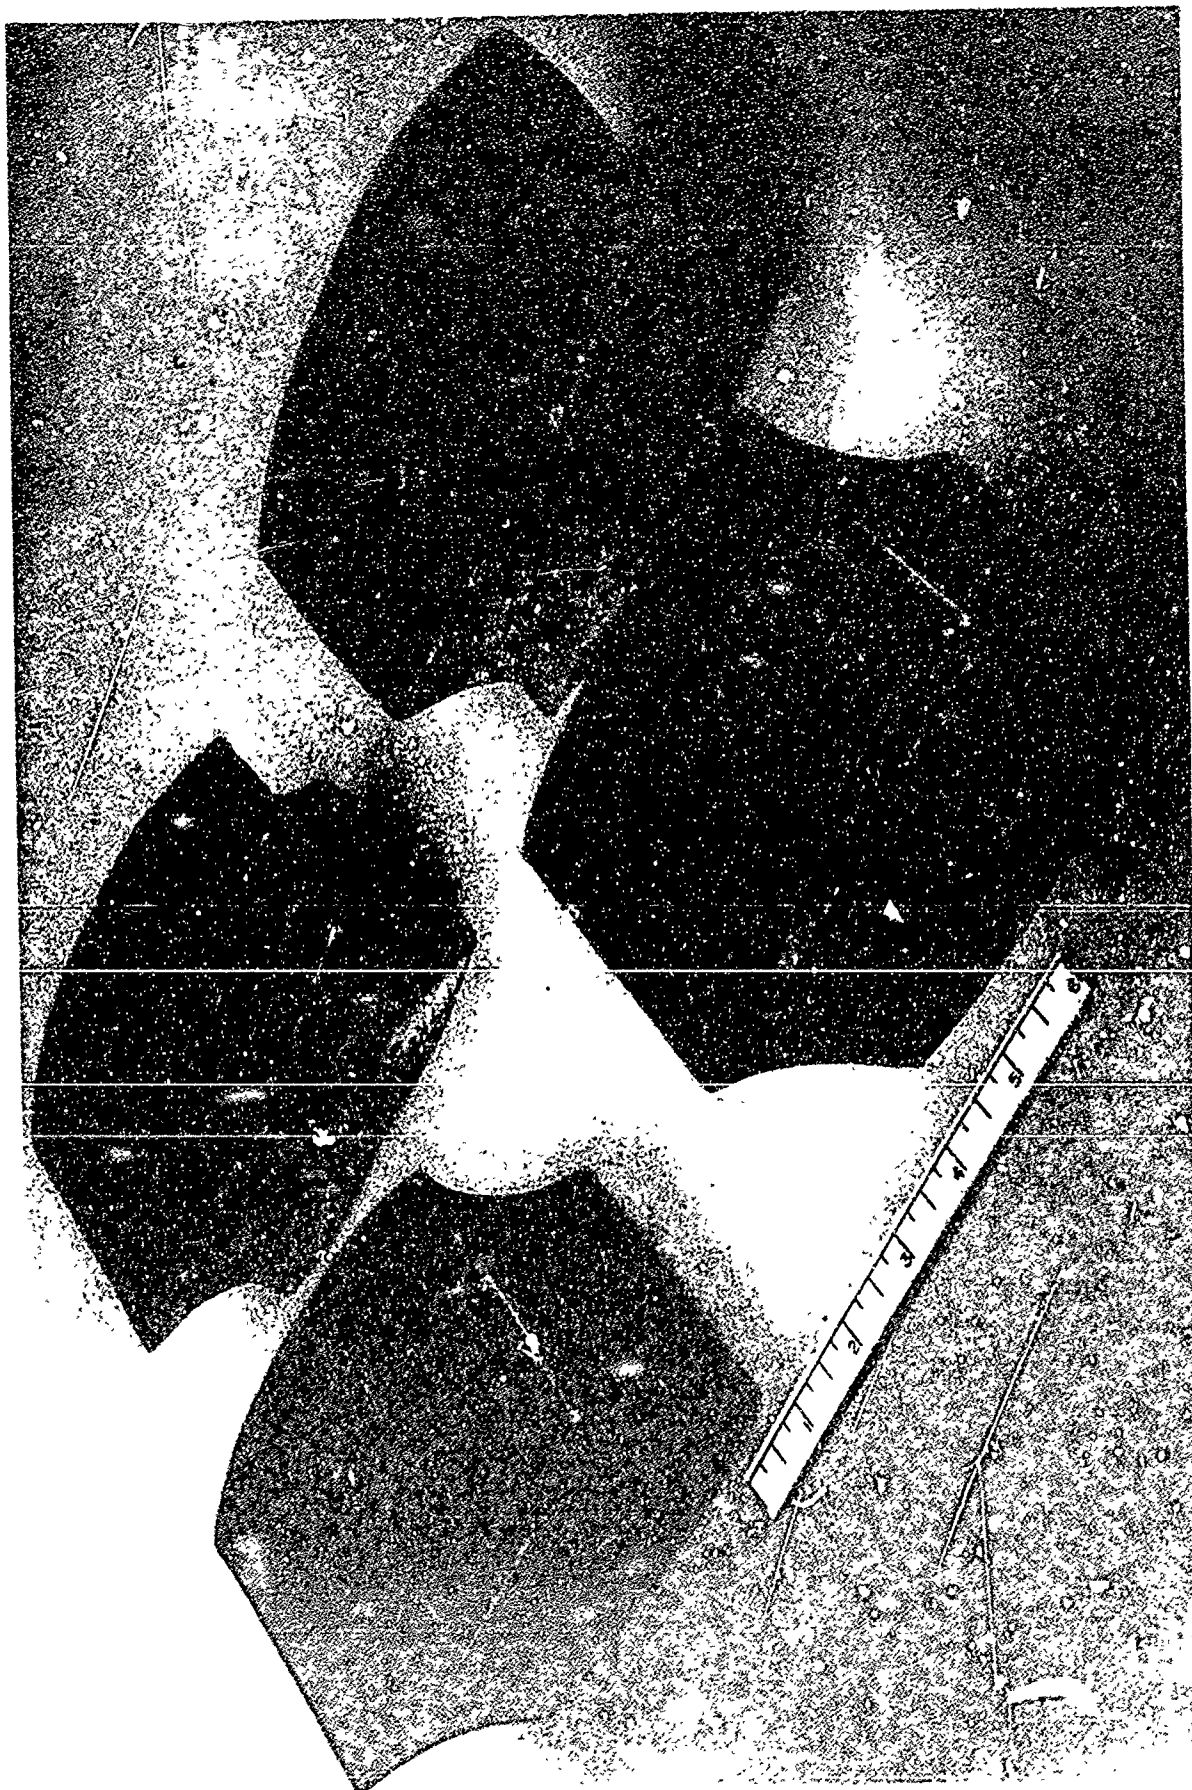
5A015-L/2/09-01F

Figure 3. Rolled Blocks from Overaged Billet BR.

The rolling was performed at the Atomics International Division of the North American Rockwell Corporation. A two-high mill having 18-in.-diameter rolls and manufactured by the Farrel Foundry and Machine Company was used in the operation. The starting blocks shown schematically in Figure 1 were oversize for the 3-in. roll gap, so they were machined to give a 3-in. by 3-in. transverse (short transverse by long transverse) cross section. Passes were made in the original longitudinal direction. The blocks were preheated in a 300 F furnace and returned to the furnace as required during the rolling. The final long transverse dimension (in the end section) was maintained close to 3 inches. Therefore, the reductions in area (of the end sections) were proportional to the reductions in the short transverse dimension (Table IV). The rolled blocks can be seen as originally oriented in the photographs of Figure 3. No cracking was encountered in the rolling.

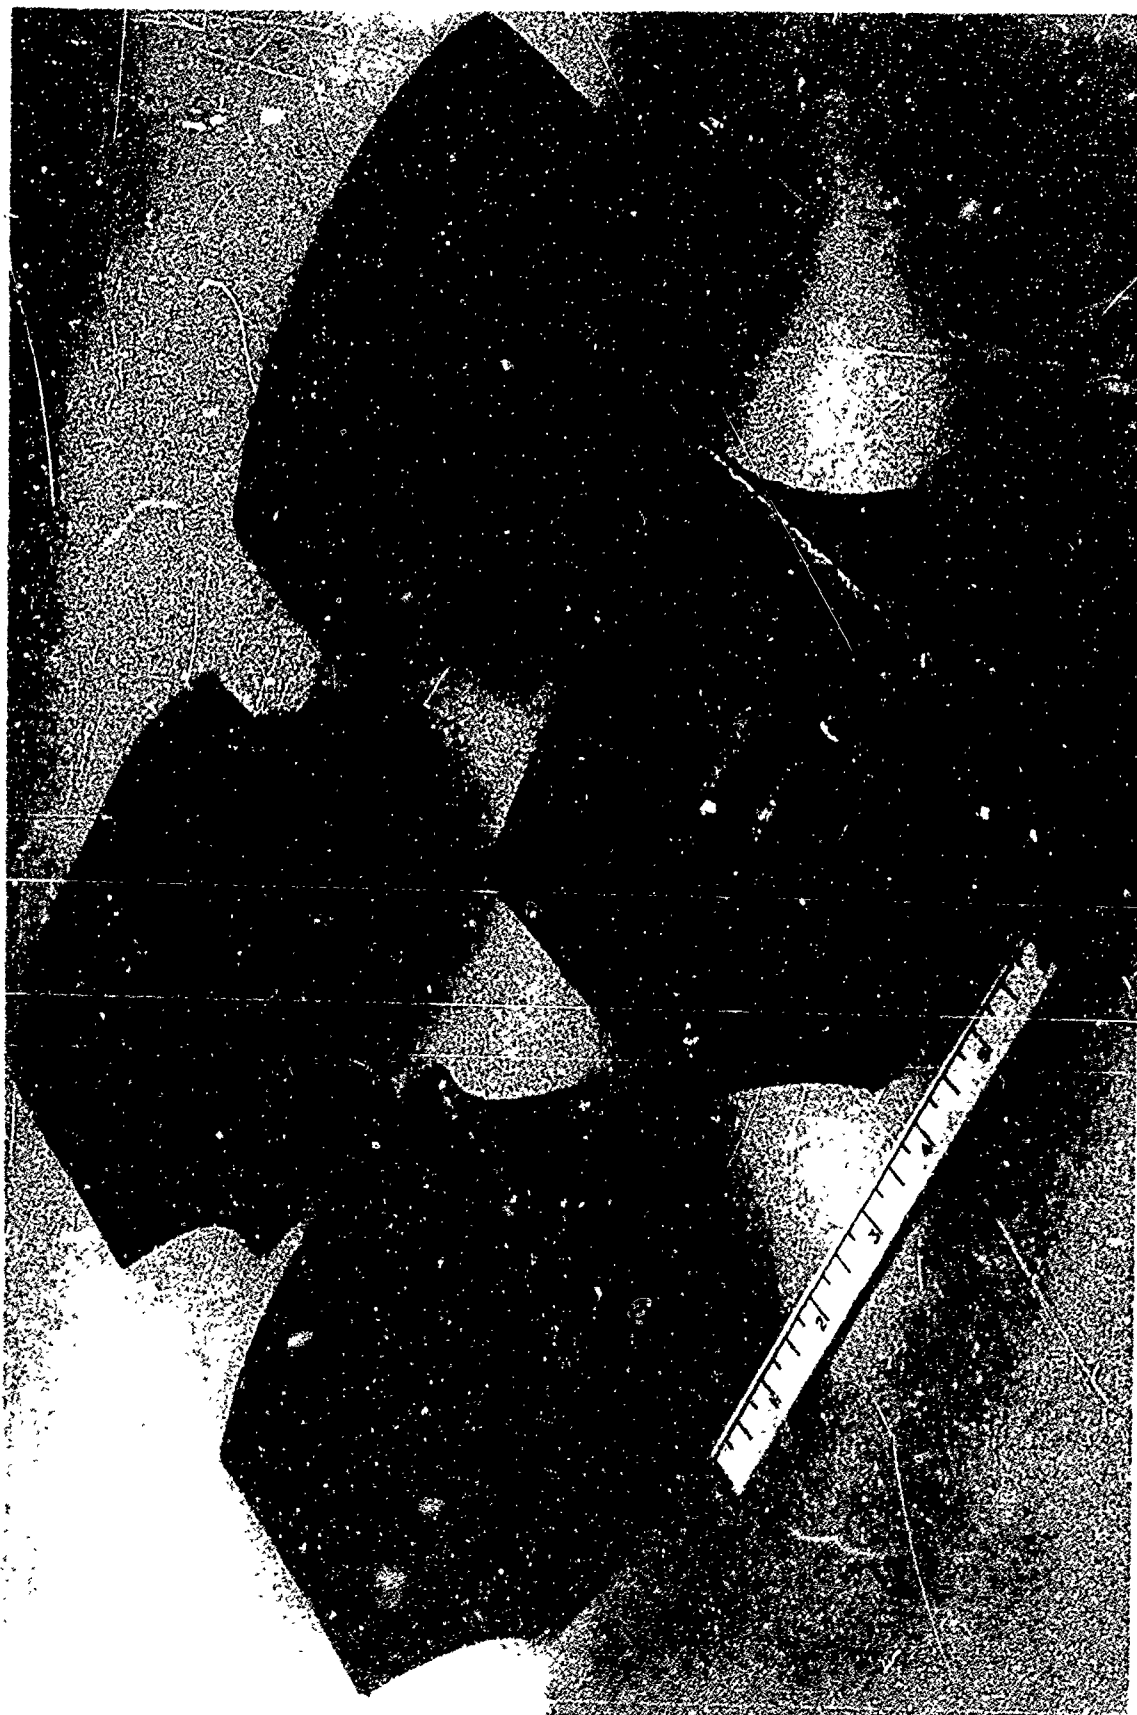
5A015-1/3/69-01A

Figure 3. Rolled Blocks from Overaged Billet CR.
